EFFECTS OF THE ATOMIC BOMB ON NAGASAKI,
JAPAN

Physical Damage Division

JUNE 1947

13 October-20 November 1945

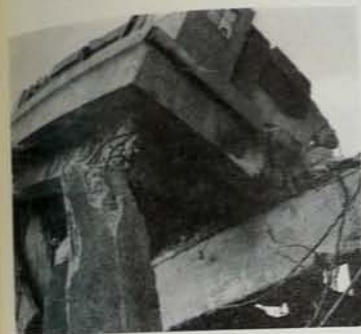
Photo 110.—Group 16, Building 2, looking north at top of collapsed southeast corner.

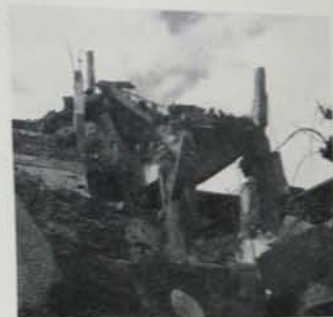
Photo 111.—Group 16, Building 2, looking west at top of east end of collapsed wall.

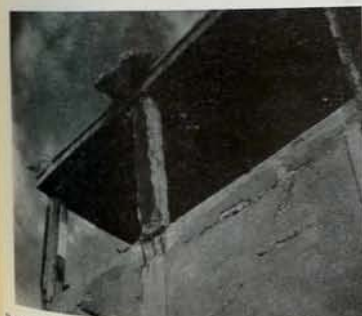
Photo 112.—Group 16, Building 2, looking northeast at top of west wall.

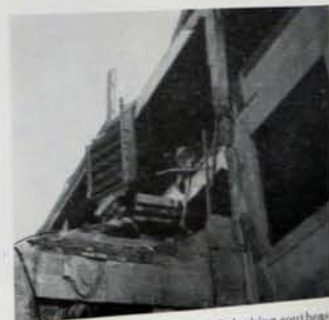
Photo 113.—Group 16, Building 2, looking southeast at damaged stairwell on north side.

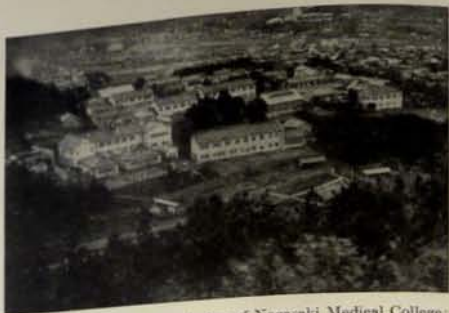
Photo 114.—1,500 feet from GZ. Group 17, general view of Nagasaki Medical College; photo taken about 1945.

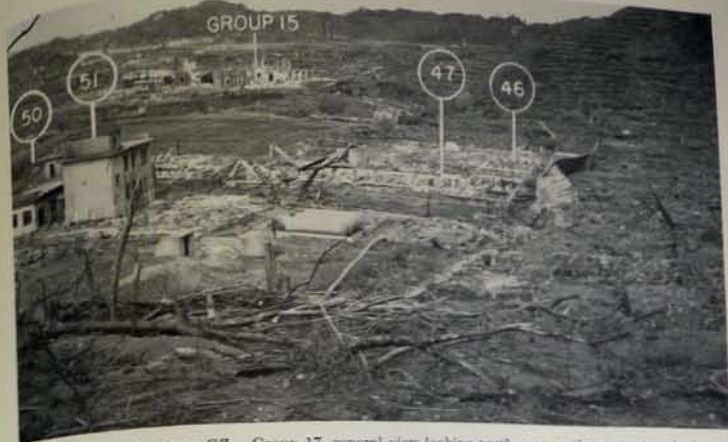
Photo 116.—1,500 feet from GZ. Group 17, general view looking north over northeast portion of school site.

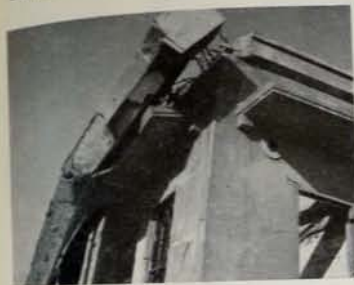
Remarks: East and west gable walls broken off at roof line by blast. Roof and interior walls destroyed by blast and fire. Photo 117.

Photo 117.—1,500 feet from GZ. Group 17, Building 28, east concrete gable broken off at eave line and slumped to east.

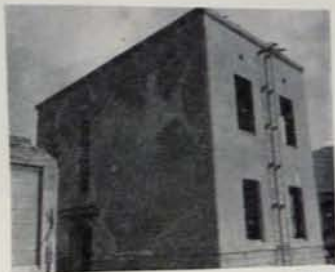
Remarks: Building structurally damaged by blast. Photo 118.

Photo 118.—1,400 feet from GZ. Group 17, Building 12, cracked concrete walls on west side of building.

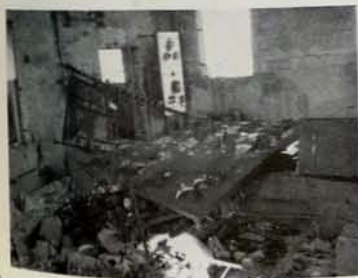
Photo 119.—1,500 feet from GZ. Group 17, Building 29, destroyed switch gear in north side of building.

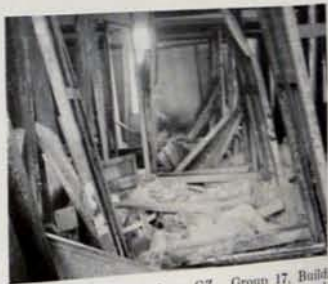
Remarks: No structural damage to this building. Wood trim and contents destroyed by fire. Photo 120.

Photo 120.—1,800 feet from GZ. Group 17, Building 61, complete combustion of paper contents stored in building.

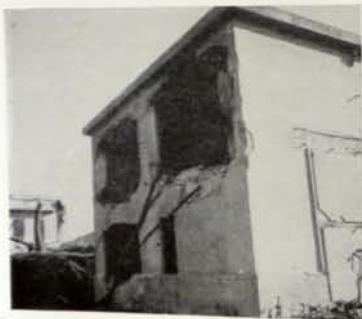
Remarks: No columns damaged. Walls between columns collapsed inward on west side of the building. Photos 122 and 123.

Photo 122.—1,500 feet from GZ. Group 17, Building 35A, destroyed concrete panel walls at west side of building.

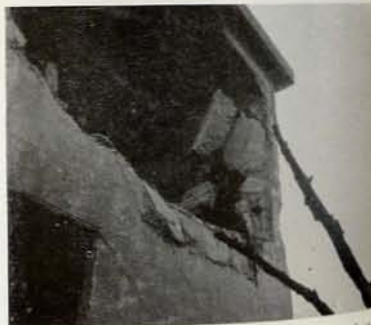
Photo 123.—Group 17, Building 35A, close-up of steel rods in concrete wall on west side of building.

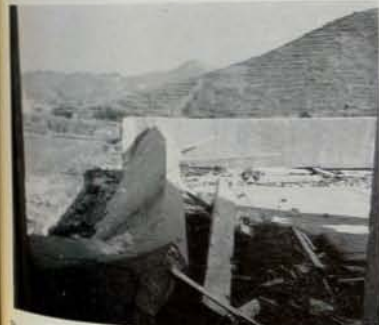
Remarks: Only structural damage to parapet walls. Photo 125.

Photo 125.—1,600 feet from GZ. Group 17, Building 51, west parapet wall collapsed in on roof.

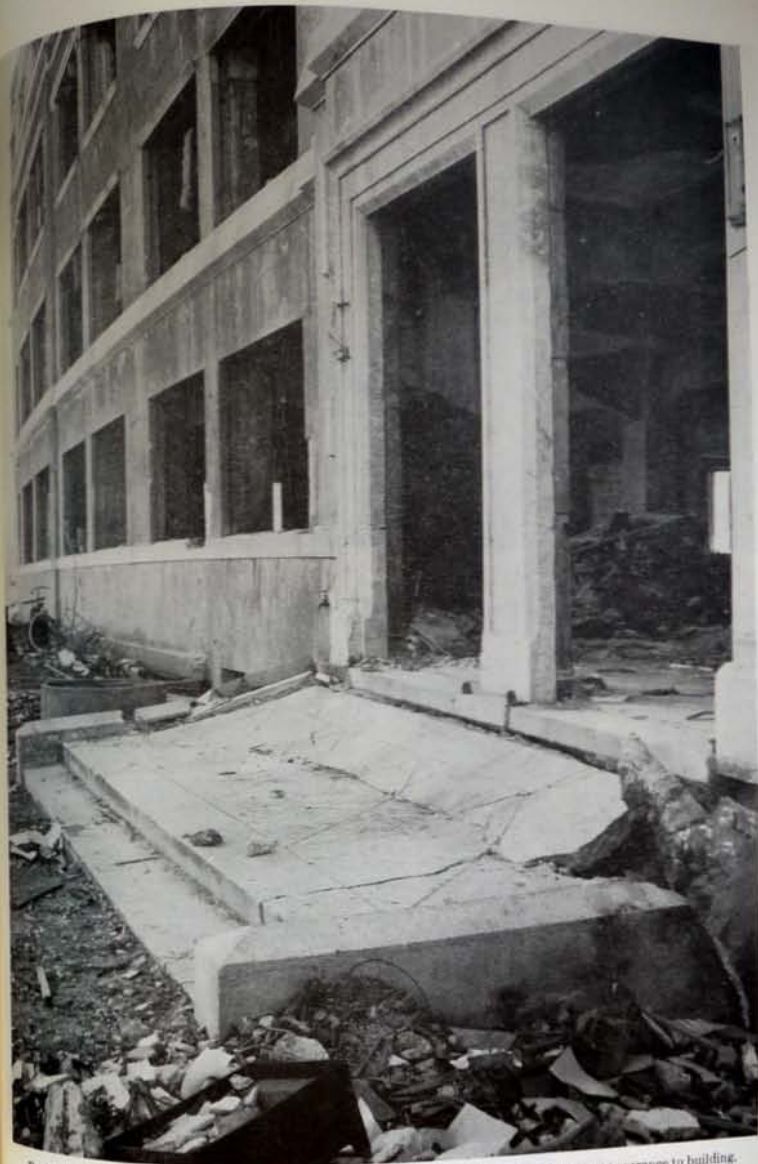
c. The downward pressure of the blast in this area was illustrated by the sinking of a concrete step and landing at the east entrance to Building 1. This concrete slab broke away from the main structure and was lowered approximately 7 inches (Photo 128).

Photo 128.—1,500 feet from GZ. Group 18, Building 1, reinforced concrete slab at east entrance to building.

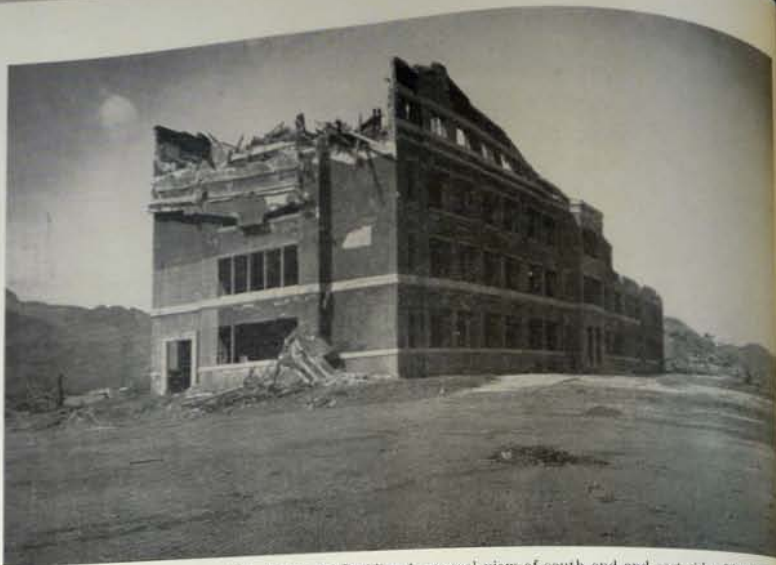
PHOTO 129.—1,500 feet from GZ. Group 18, Building 1, general view of south end and east side of building.

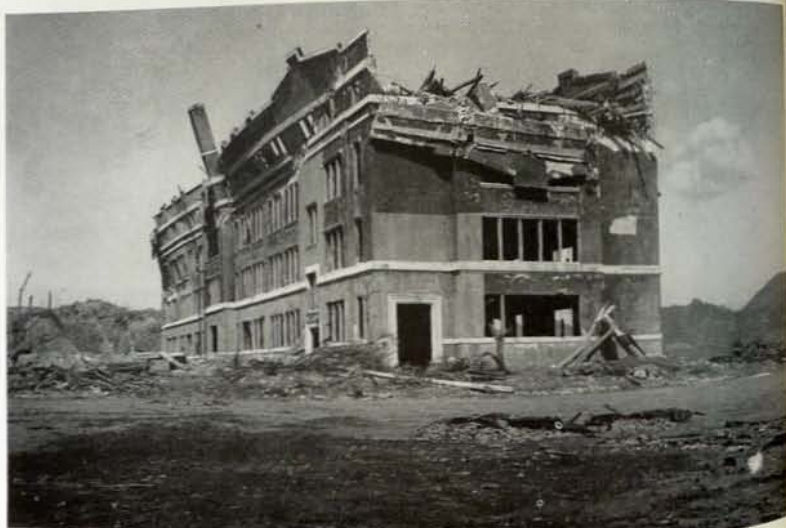
PHOTO 130.—Group 18, Building 1, general view of south end and west side of building.

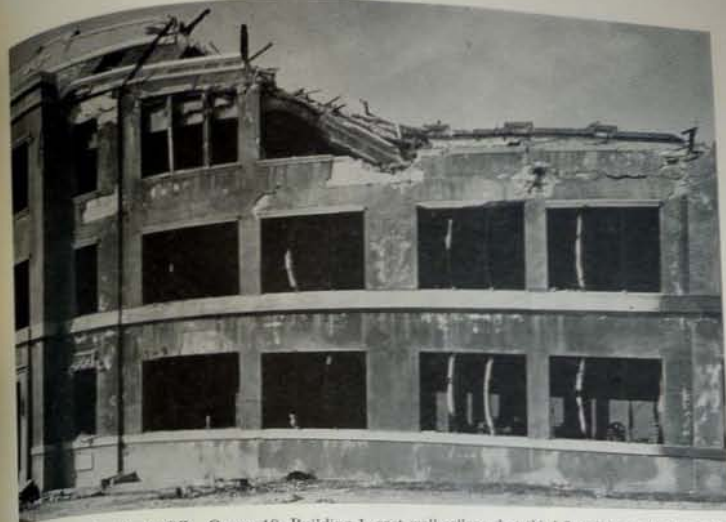
PHOTO 131.—1,500 feet from GZ. Group 18, Building 1, east wall collapsed at third floor line at north end of building.

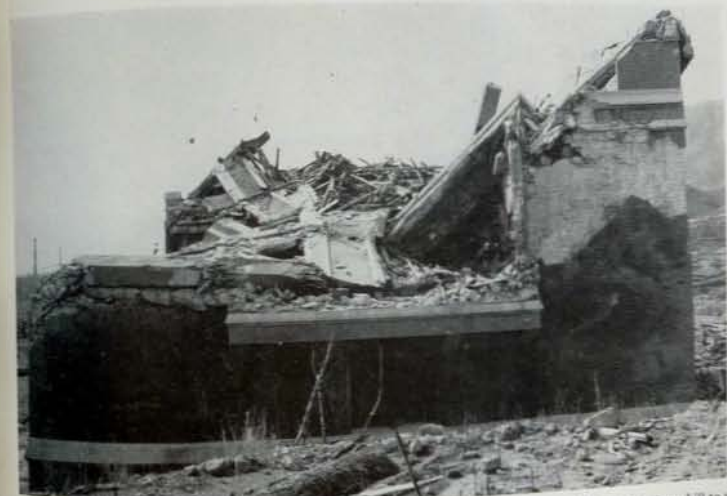
PHOTO 132.—Group 18, Building 1, view of north end of building above third floor line. Photo taken from hill to north of building.

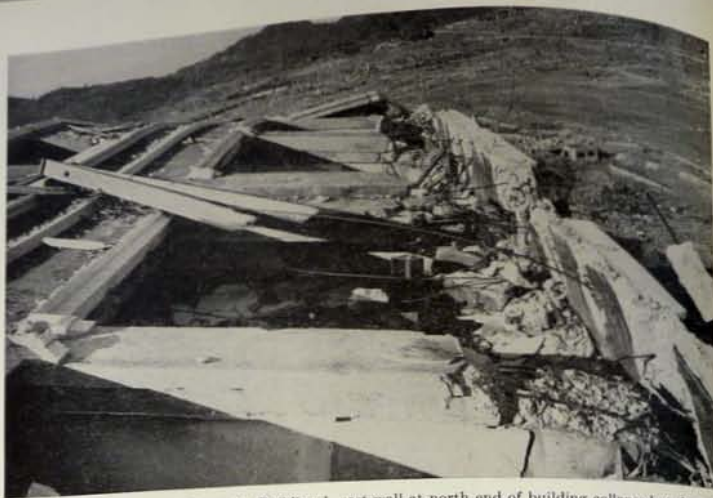
PHOTO 133.—1,500 feet from GZ. Group 18, Building 1, east wall at north end of building collapsed at third floor level.

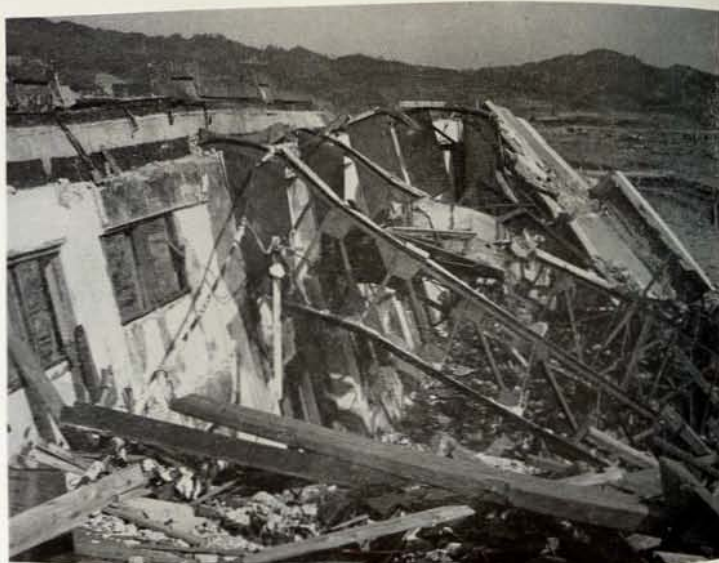
PHOTO 134.—Group 18, Building 1, west wall at north end of building leaning west. Steel roof girders collapsed at east wall.

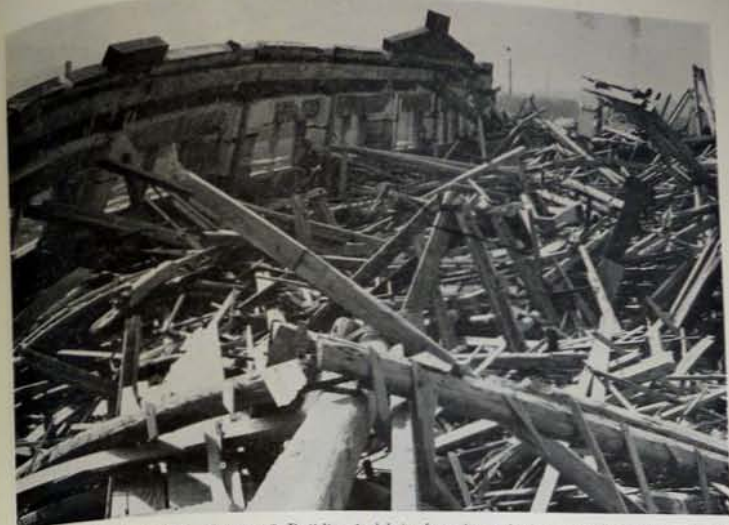
PHOTO 135.—1,500 feet from GZ. Group 18, Building 1, debris of wooden roof trusses, and leaning east wall above fourth floor level at south end of building.

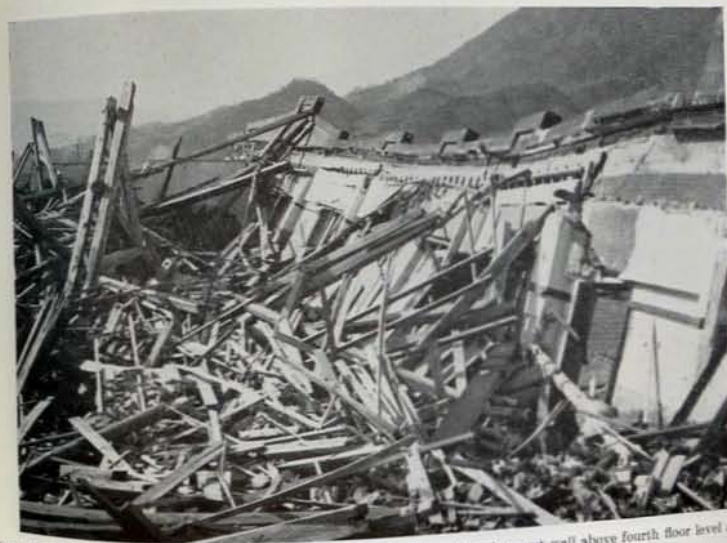
PHOTO 136.—Group 18, Building 1, debris of wooden roof truss, and leaning west wall above fourth floor level at south end of building.

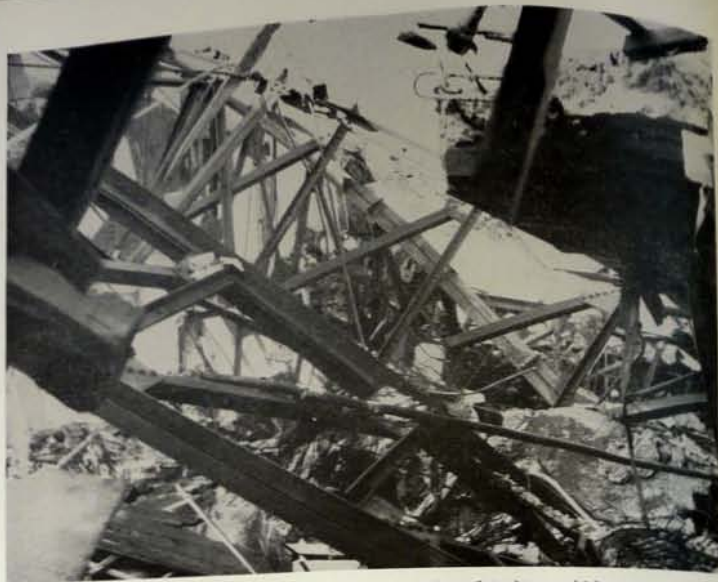
PHOTO 137.—1,500 feet from GZ. Group 18, Building 1, detail view of collapsed steel truss which supported roof over north portion of building.

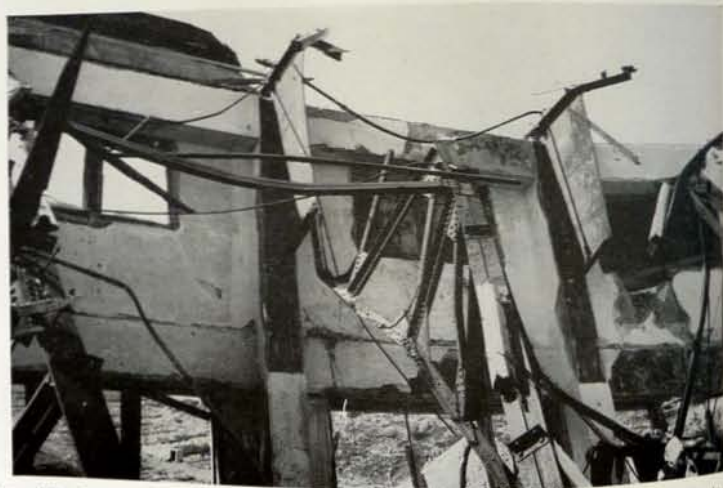
PHOTO 138.—Group 18, Building 1, top chord of Truss 14 pulled away from steel plate riveted to steel column.

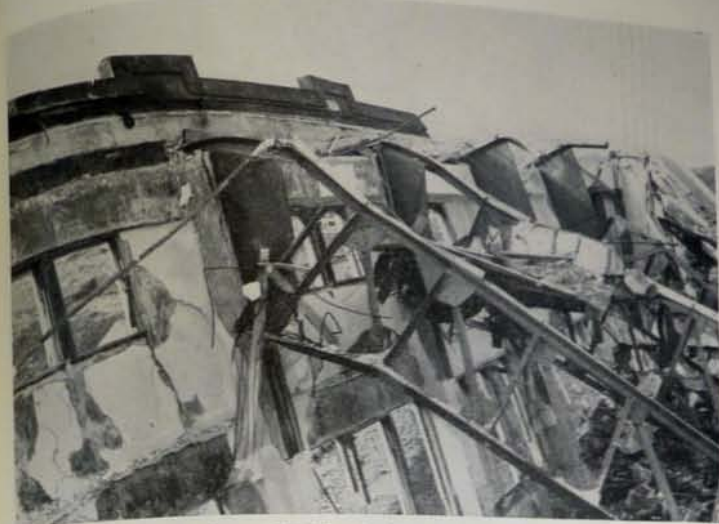
PHOTO 139.—1,500 feet from GZ. Group 18, Building 1, looking north at west end of steel trusses remaining attached to top of west wall.

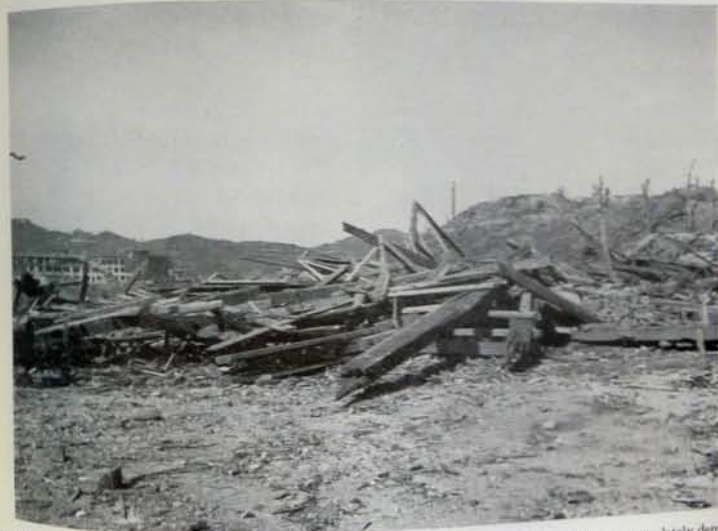
Remarks: Building demolished by blast. Photo 140.

PHOTO 140.—1,600 feet from GZ. Group 18, Building 2, debris of this wooden building which was completely demolished by blast.

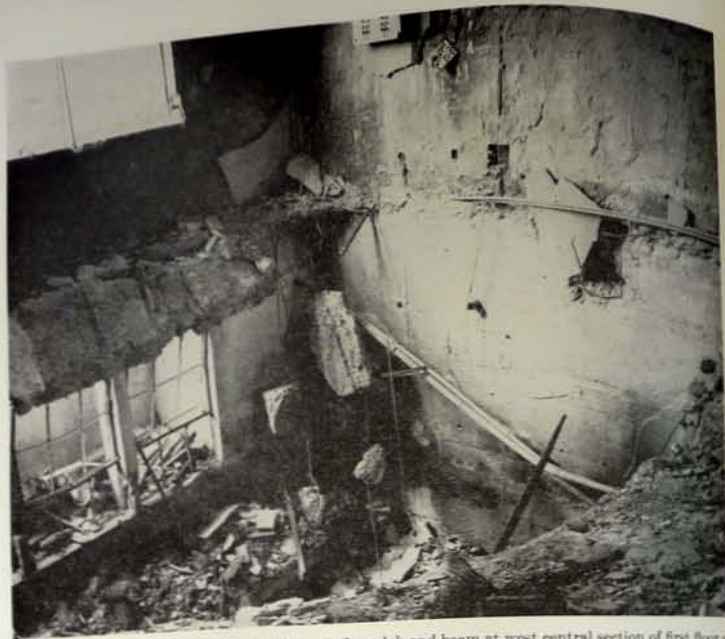
Photo 141.—1,500 feet from GZ. Group 18, Building 1, floor slab and beam at west central section of first floor collapsed into basement.

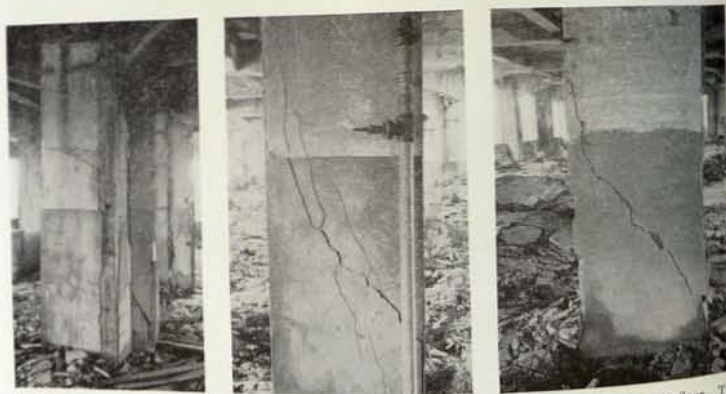
Photo 142.—Group 18, Building 1, failure in Columns 8B on first floor, 9B on third floor, and 3B on first floor. Typical column failures throughout building.

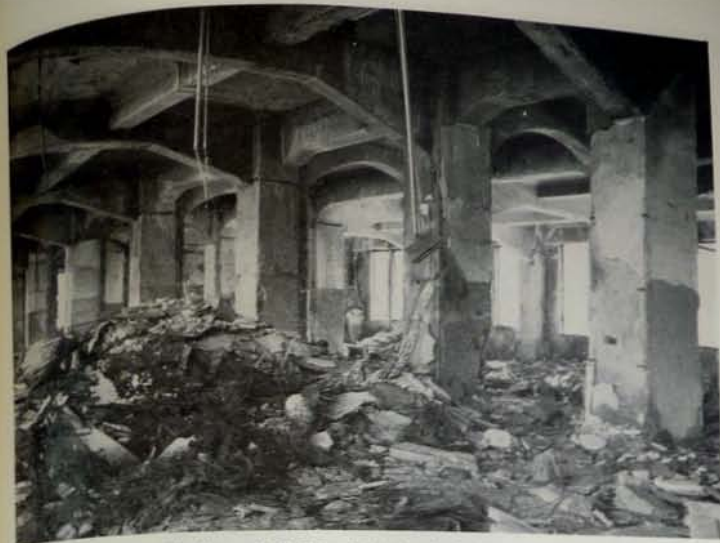
Photo 143.—1,500 feet from GZ. Group 18, Building 1, interior view looking south on second floor showing fire and blast damage.

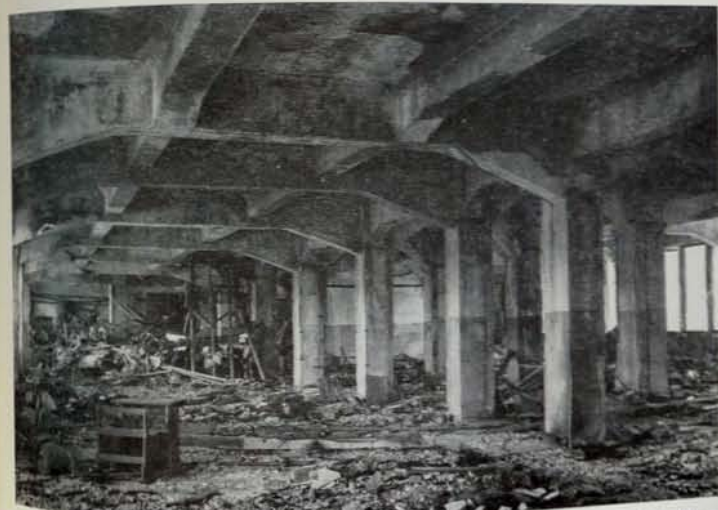
Photo 144.—Group 18, Building 1, interior view looking south on third floor, showing blast and fire damage.

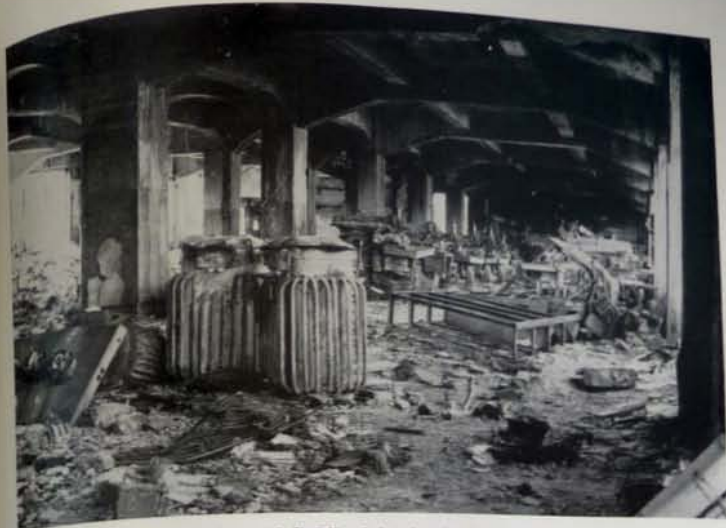
Photo 146.—1,500 feet from GZ. Group 18, Building 1, interior view looking north on first floor showing blast and fire damage.

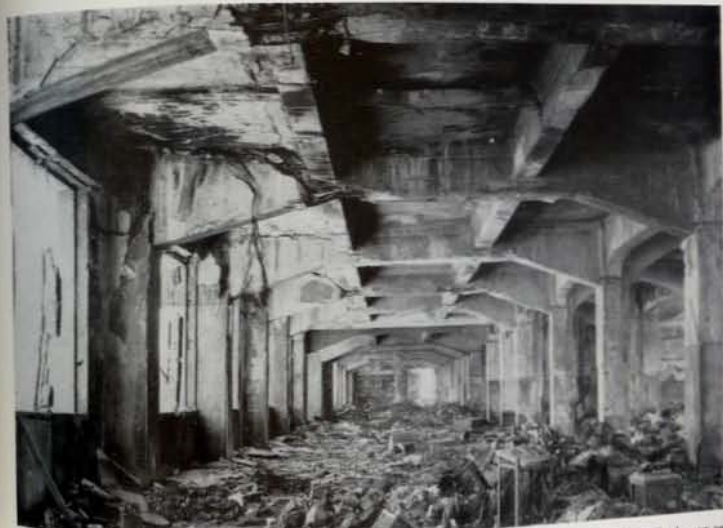
Photo 147.—Group 18, Building 1, interior view looking south on first floor. Second floor beams cracked near east wall.

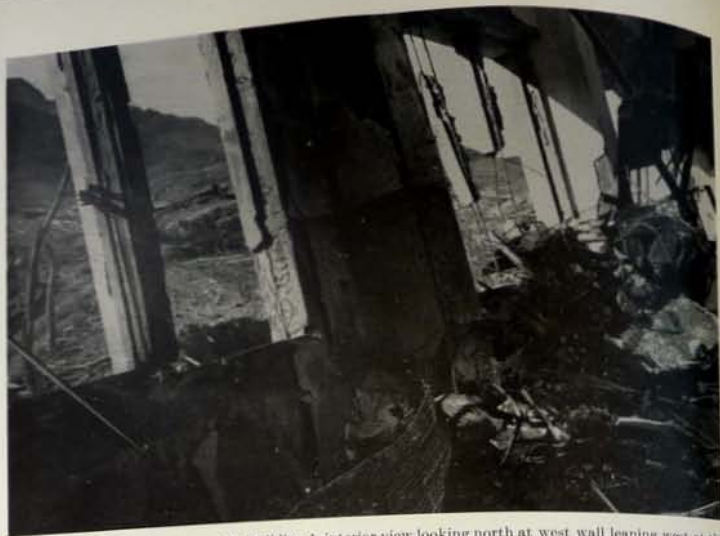
PHOTO 148.—1,500 feet from GZ. Group 18, Building 1, interior view looking north at west wall leaning west at third floor line.

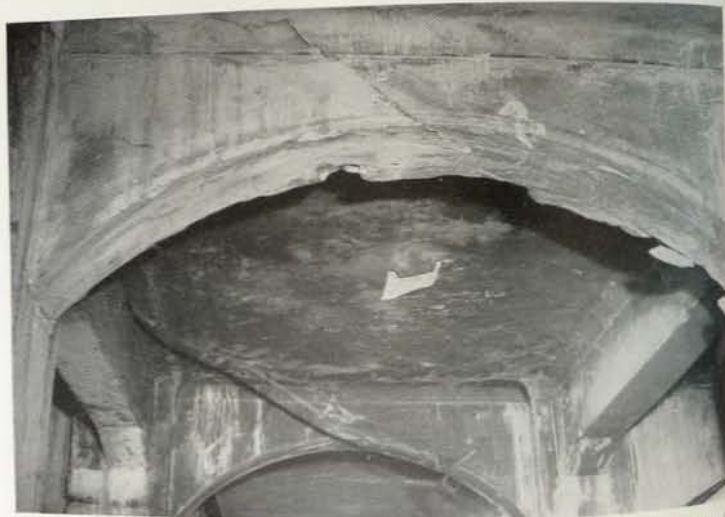
PHOTO 149.—Group 18, Building 1, Beam 10, between column rows B and C, supporting third floor. Crack shown is typical of these in center section of building.

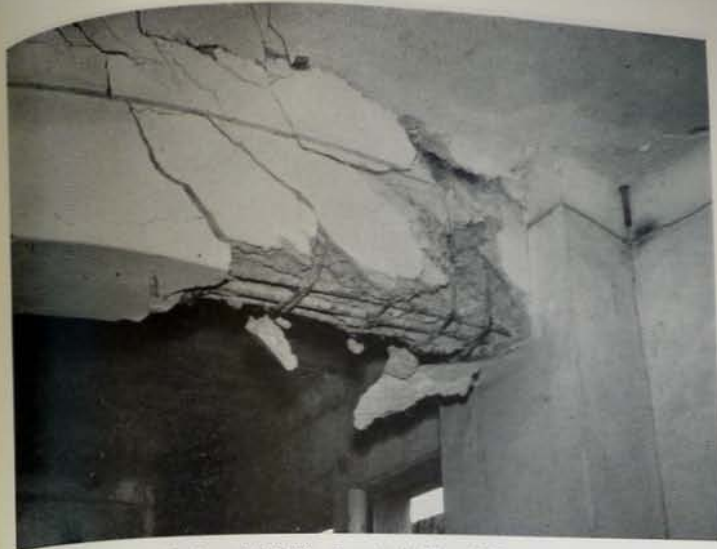
PHOTO 150.—1,500 feet from GZ. Group 18, Building 1, east end of Beam 10AB supporting first floor. This beam depressed 7 inches in center of 22-foot span.

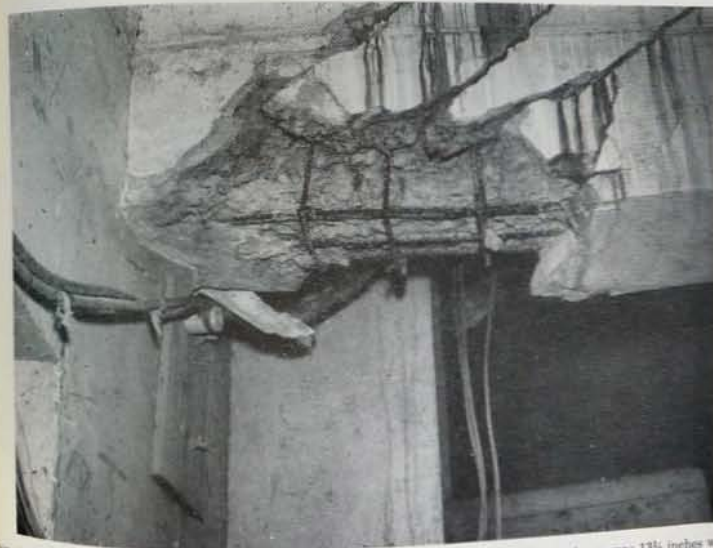
PHOTO 151.—Group 18, Building 1, west end of Beam 10AB supporting first floor. This beam was 13½ inches wide and 20 inches deep.

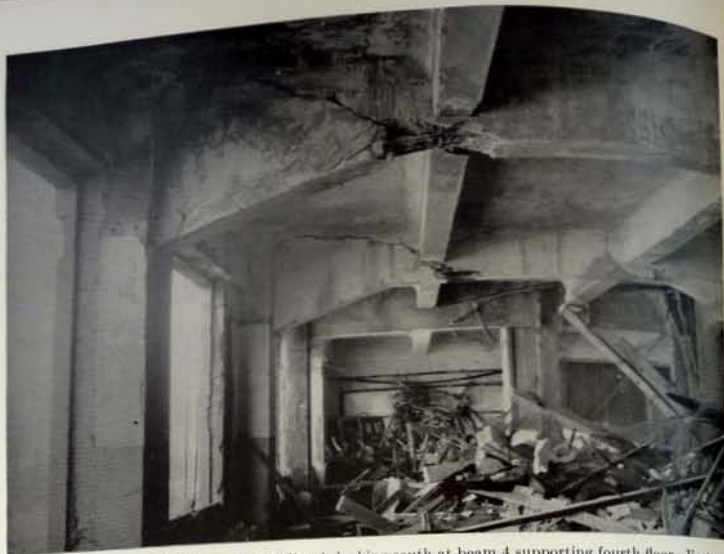
Photo 152.—1,500 feet from GZ. Group 18, Building 1, looking south at beam 4 supporting fourth floor. Failure typical of Beams 3, 4, 5, and 6 on this floor.

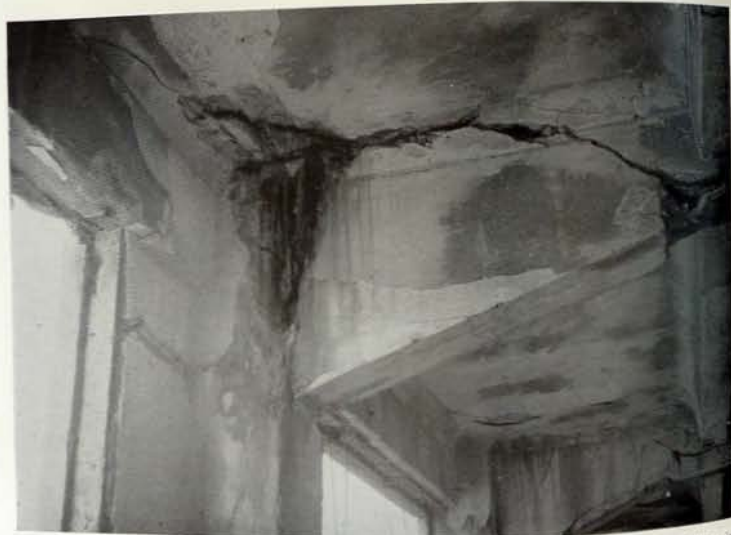
Photo 153.—Group 18, Building 1, looking south at Beam 12 supporting third floor. Cracks typical of failure in Beams 10, 11, 12, 13, 14, and 15 on this floor.

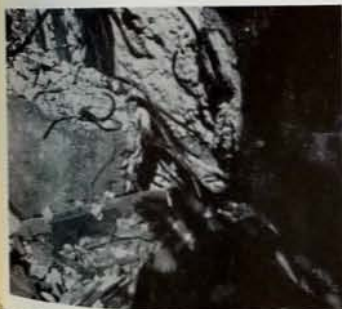
Photo 155.—Group 18, Building 1, base of Column 13A at third floor line.

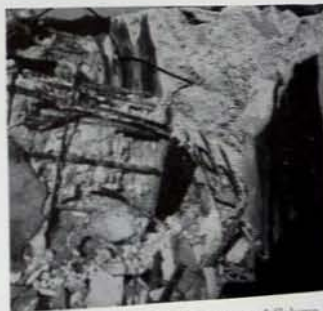
Photo 156.—Group 18, Building 1, base of Column 13A at third floor line showing anchor bolts pulled from concrete.

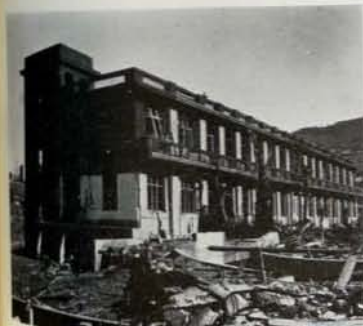
Puoro 159.—2,100 feet from GZ. Group 20, Building 16, damaged west end and south side of building.

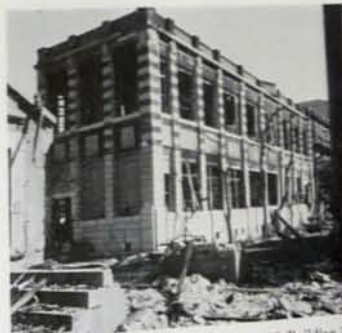
Puoro 160.—2,200 feet from GZ. Group 20, Building 18, west end and south side of building.

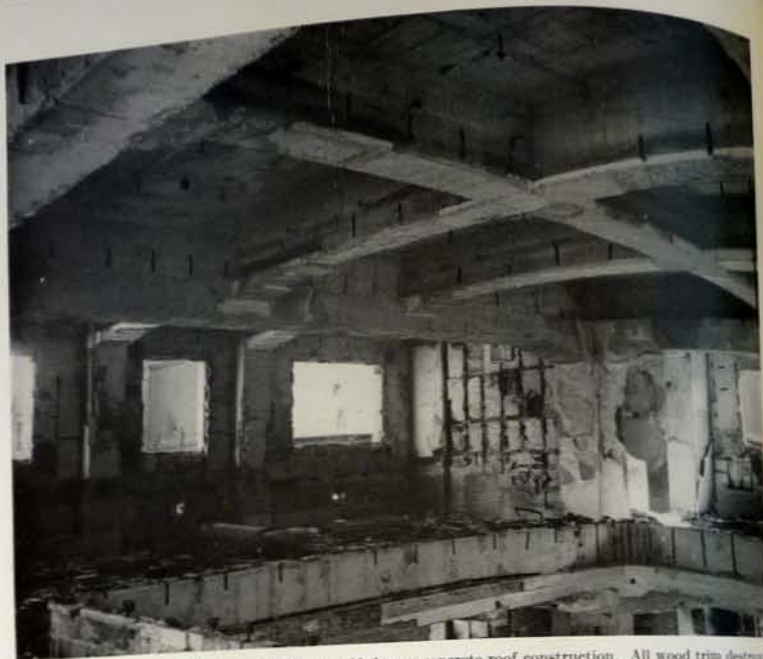
Remarks: No damage to reinforced-concrete frame. All wood and plaster trim destroyed by fire.
Photo 161.

Photo 161.—2,300 feet from GZ. Group 20, Building 20, heavy concrete roof construction. All wood trim destroyed by fire.

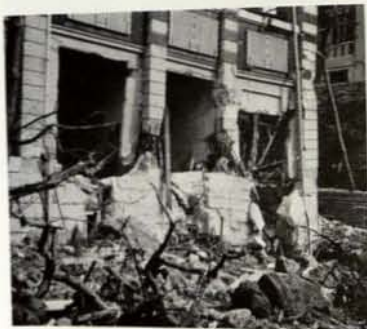
Photo 162.—Group 20, Building 18, damage caused by high-explosive bomb to southeast corner of building prior to 9 August 1945.

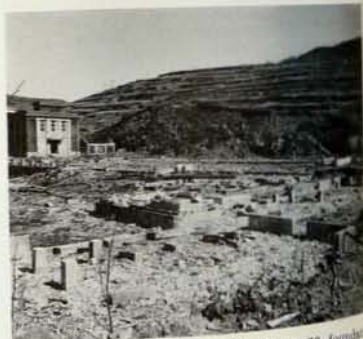
Remarks: No damage to reinforced-concrete frame; Superficial damage only by atomic bomb. No fire damage. Photos 163 and 181.

Photo 163.—2,400 feet from GZ. Group 20, foundation walls remaining at east side of site. Building 3 at left of photo.

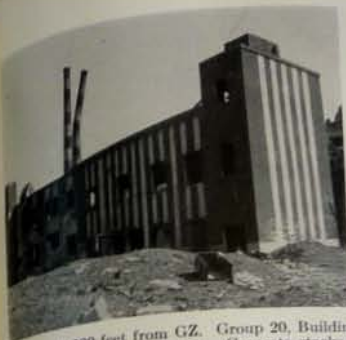
Remarks: No structural damage to reinforced-concrete frame. Damage to interior caused by blast and fire. Photos 164, 166, 194, and 200.

Photo 164.—2,500 feet from GZ. Group 20, Building 24, general view looking northwest. Concrete stacks from Building 23 in background.

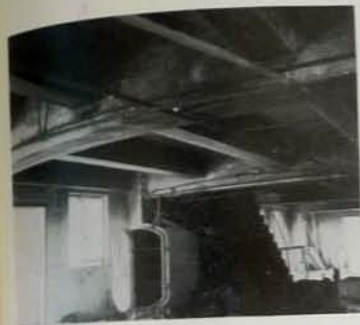
Photo 166.—2,500 feet from GZ. Group 20, Building 24, first-floor beams showing typical heavy construction.

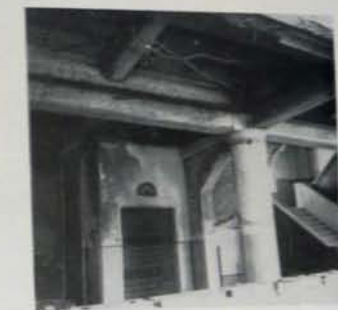
Remarks: No damage to reinforced-concrete frame. Photos 167 and 201.

Photo 167.—2,400 feet from GZ. Group 20, Building 26, view in main lobby showing typical construction.

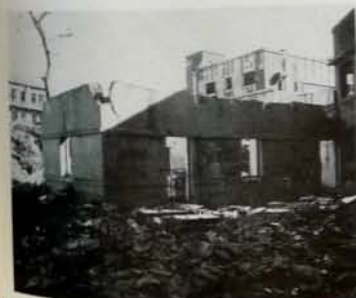
Remarks: Complete structural damage. Photos 168 and 205.

Photo 168.—2,400 feet from GZ. Group 20, Building 28, shattered brick walls and burned roof.

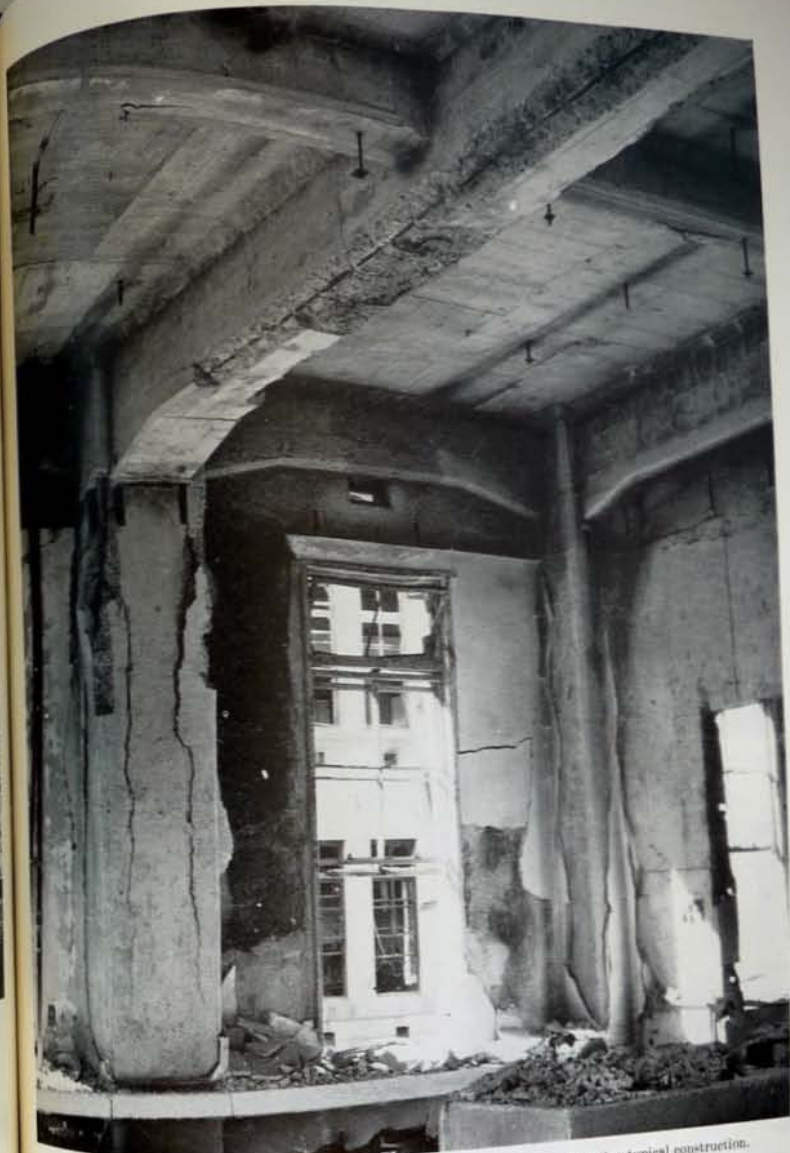
Remarks: Only damage to reinforced-concrete frame is to parapet wall as shown. Fire extends over all floors. Photos 170 and 171.

Photo 171.—2,200 feet from GZ. Group 20, Building 29, interior view showing typical construction.

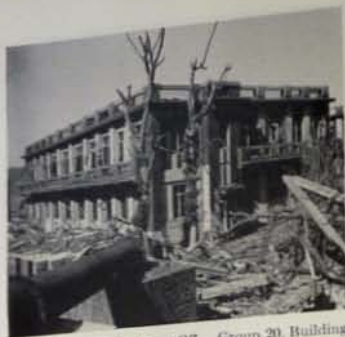
Remarks: No damage to reinforced-concrete frames of building. No fire. Photo 172.

Photo 172.—2,400 feet from GZ. Group 20, Building 12, general view looking northwest.

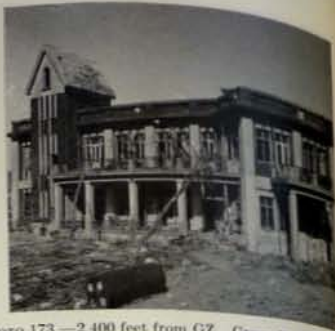
Remarks: No damage to reinforced-concrete frame of building. No fire. Photo 173.

Photo 173.—2,400 feet from GZ. Group 20, Building 11, general view looking northwest. Debris of Building 12 at left.

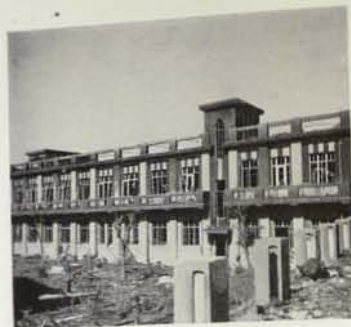
Remarks: No damage to reinforced-concrete frame. Photo 174.

Photo 174.—2,200 feet from GZ. Group 20, Building 13, south side of undamaged building.

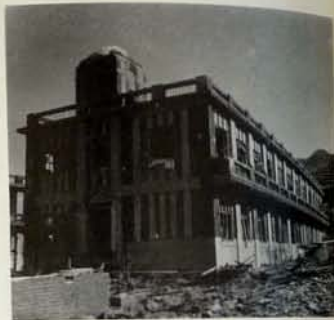
Remarks: No damage to reinforced-concrete frame. No fire. Photo 175.

Photo 175.—2,200 feet from GZ. Group 20, Building 14, south side and west end of building.

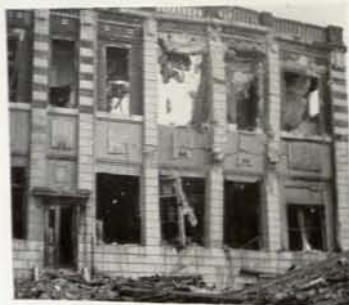
Photo 176.—Group 20, Building 17, damage caused by high-explosive bomb prior to 9 August 1945.

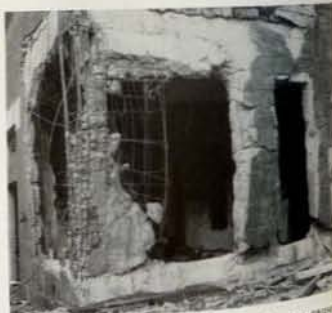
Remarks: All structural damage, except to parapet walls, caused by 500-pound high-explosive bombs. Photos 169, 177, 186, 187, 188, 189, 190, 191, 197, and 199.

Photo 177.—Group 20, Building 32, damage caused at southwest corner of building by high-explosive bomb prior to 9 August 1945.

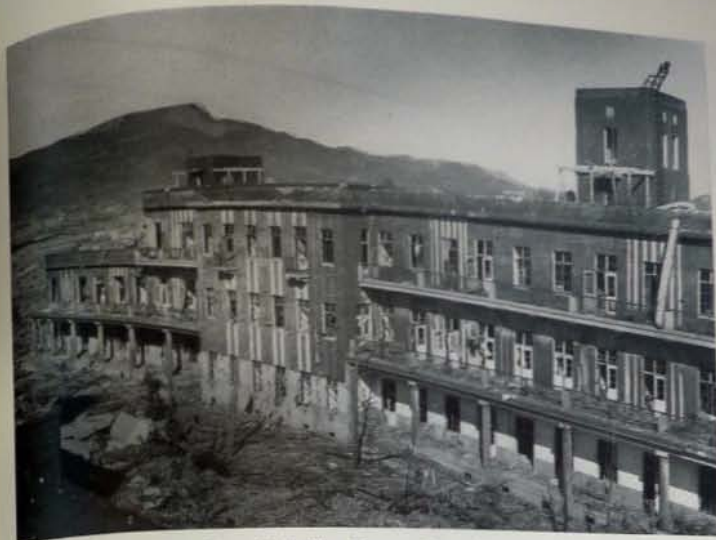
Remarks: No structural damage to this building. Fire and blast caused superficial damage. Photo 178.

Photo 178.—1,400 feet from GZ. Group 20, Building 33, general view of south side of building. Photo taken from roof of Building 20.

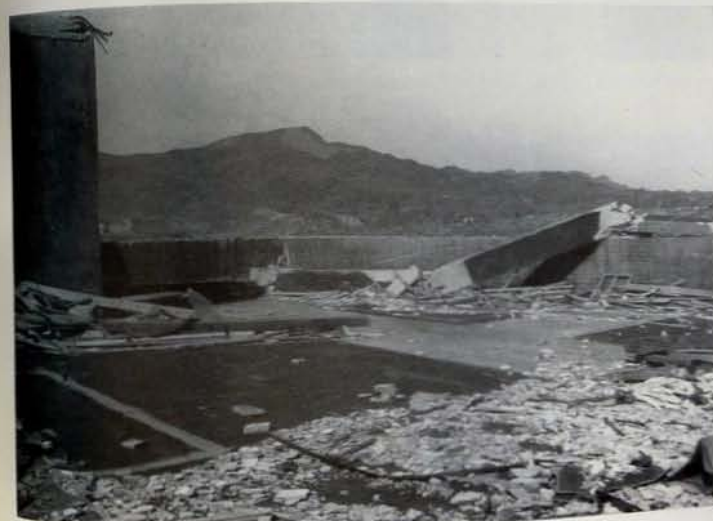
Remarks: No structural damage to this building. Superficial damage by blast and fire. Photos 179, 182, 195, and 196.

Photo 179.—1,800 feet from GZ. Group 20, Building 37, capping blown off top of parapet wall at northwest corner of building.

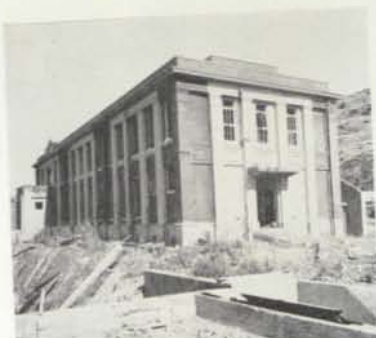
Photo 181.—2,100 feet from GZ. Group 20, Building 5, undamaged west side and south end of building.

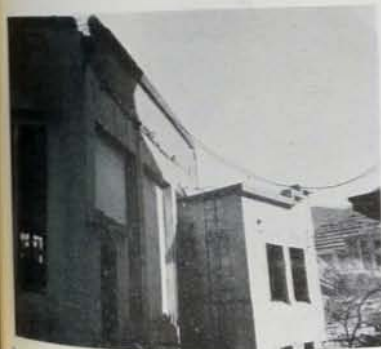
Remarks: Only structural damage to parapet walls, broken at roof line. All superficial damage by blast and fire. Photos 180, 184, and 198.

Photo 184.—1,800 feet from GZ. Group 20, Building 38, parapet on east wall cracked at roof line.

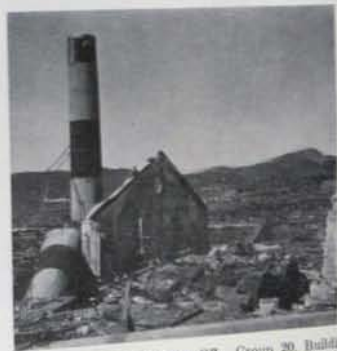
Remarks: Only west end wall remained standing. Remainder of building demolished by blast and fire. Photo 185.

Photo 185.—1,900 feet from GZ. Group 20, Building 38B general view looking northwest at remaining west wall.

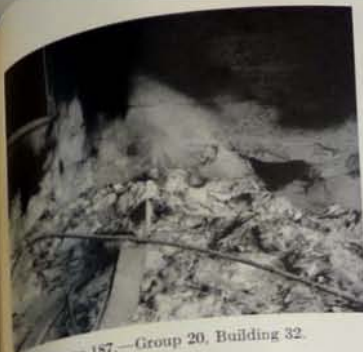
Photo 187.—Group 20, Building 32.

Photos 187 to 192.—2,200 feet from GZ. Complete combustion of contents in various rooms of reinforced-concrete hospital buildings.

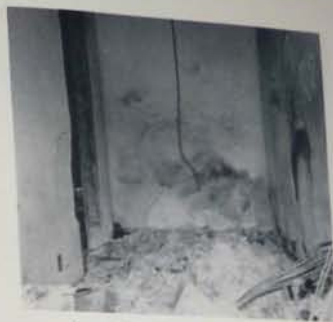
Photo 188.—Group 20, Building 32.

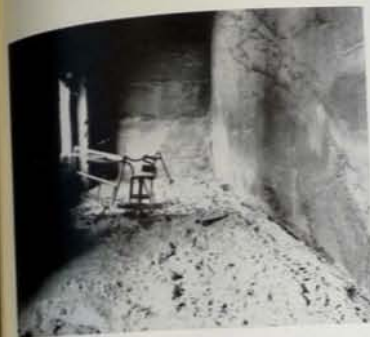
Photo 189.—Group 20, Building 32.

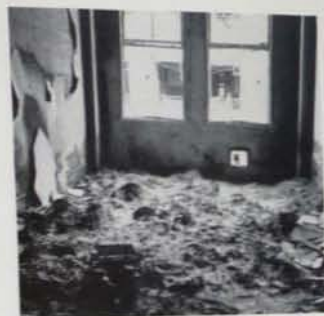
Photo 190.—Group 20, Building 32.

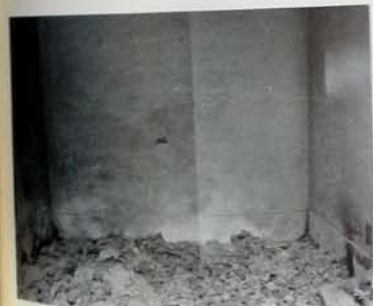
Photo 191.—Group 20, Building 32.

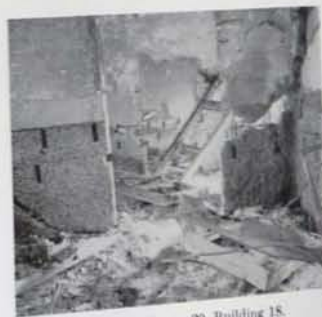
Photo 192.—Group 20, Building 18.

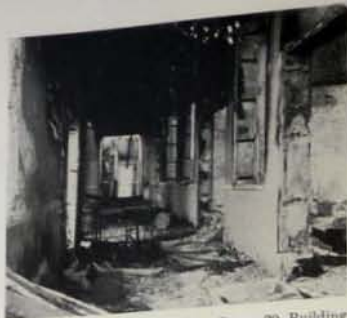
Remarks: No structural damage to reinforced-concrete frame. All damage done by blast and fire.
Photo 193.

PHOTO 193.—2,300 feet from GZ. Group 20, Building 19, partial view of burned interior.

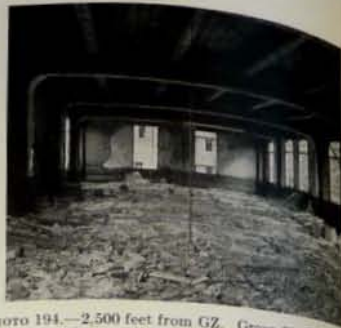
PHOTO 194.—2,500 feet from GZ. Group 20, Building 20, interior of commissary. Second floor destroyed by fire.

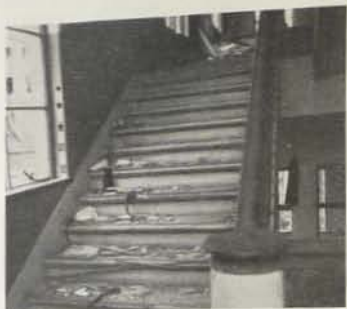
PHOTO 195.—1,800 feet from GZ. Group 20, Building 37, view of east stair undamaged by fire, although combustible material in corridor was completely consumed.

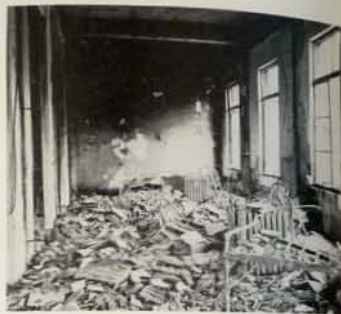
PHOTO 196.—1,800 feet from GZ. Group 20, Building 21, ward, second floor, completely burned out.

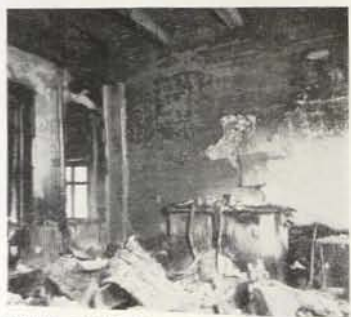
PHOTO 197.—2,100 feet from GZ. Group 20, Building 32, intense fire in southeast corner of building.

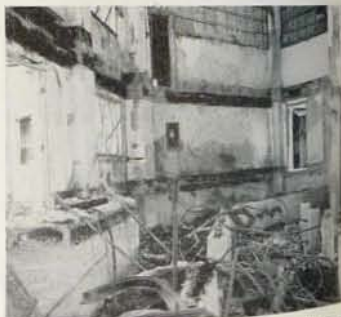
PHOTO 198.—1,800 feet from GZ. Group 20, Building 26, complete destruction of interior of operating theater by fire.

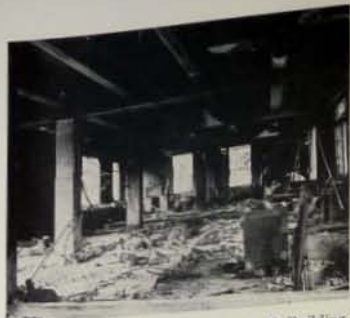
Photo 200.—2,500 feet from GZ. Group 20, Building 24, kitchen, first-floor commissary building burned out.

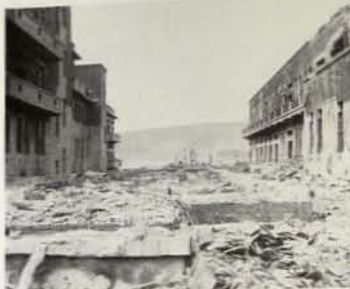
Remarks: Completely destroyed by blast and fire. Photo 202.

Photo 202.—2,200 feet from GZ. Group 20, Building 30, wood-framed infirmary completely destroyed by blast and fire.

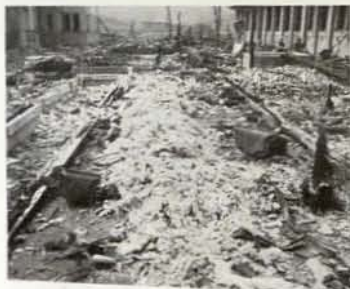
Photo 204.—2,200 feet from GZ. Group 20, wood-framed passageway between Buildings 17 and 18 destroyed by blast and fire.

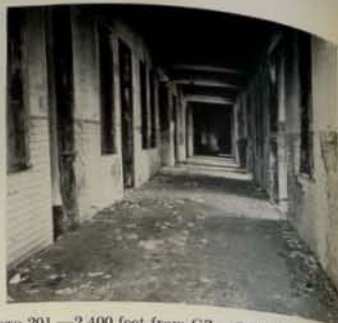
Photo 201.—2,400 feet from GZ. Group 20, Building 25, showing complete combustion of wood floor, burning door and window frames, in reinforced-concrete administration building.

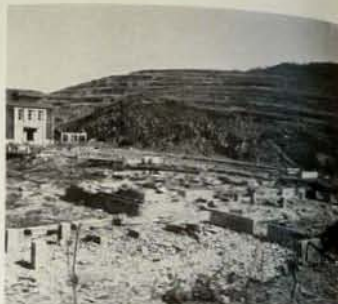
Remarks: Completely destroyed by blast and fire caused by atomic bomb. Photo 203.

Photo 203.—2,400 feet from GZ. Group 20, Buildings 7, 8, 9, and 10, looking north. Complete destruction by blast and fire.

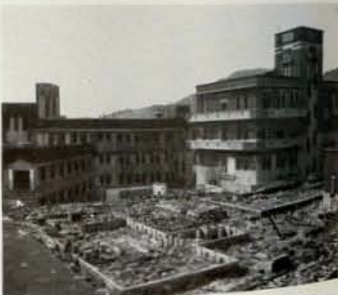
Photo 205.—2,400 feet from GZ. Group 20, Building 8, completely destroyed by blast and fire.

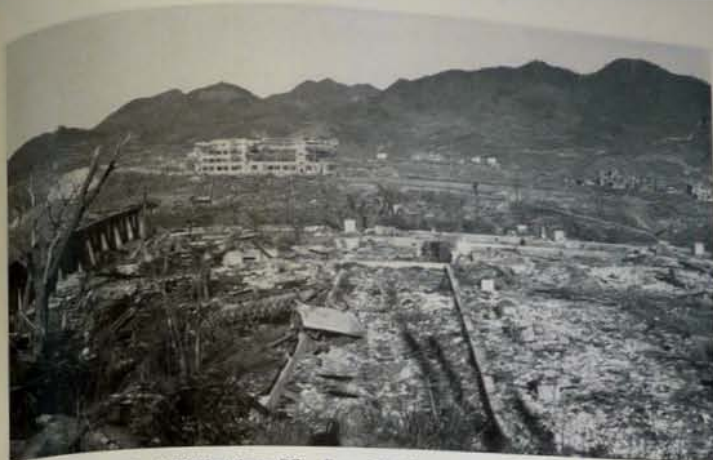
Photo 206.—2,700 feet from GZ. Group 24, TB sanatorium destroyed by blast and fire.

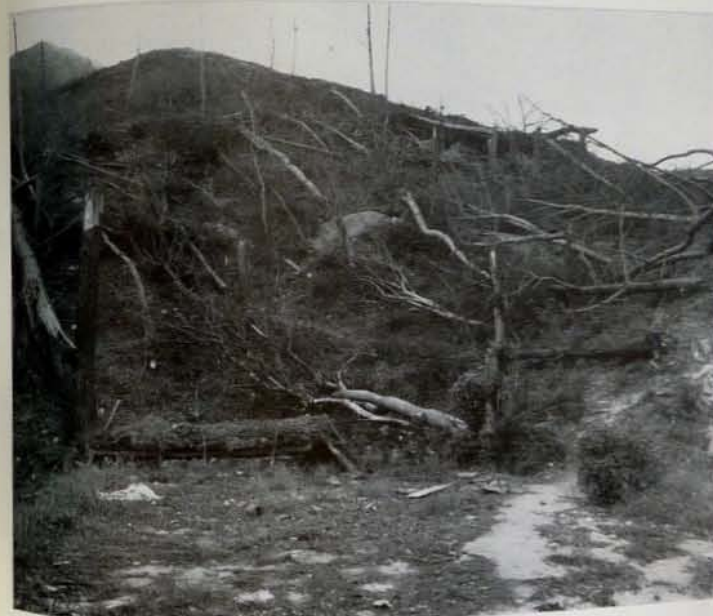
Photo 207.—2,700 feet from GZ. Group 24, fallen trees behind sanatorium.

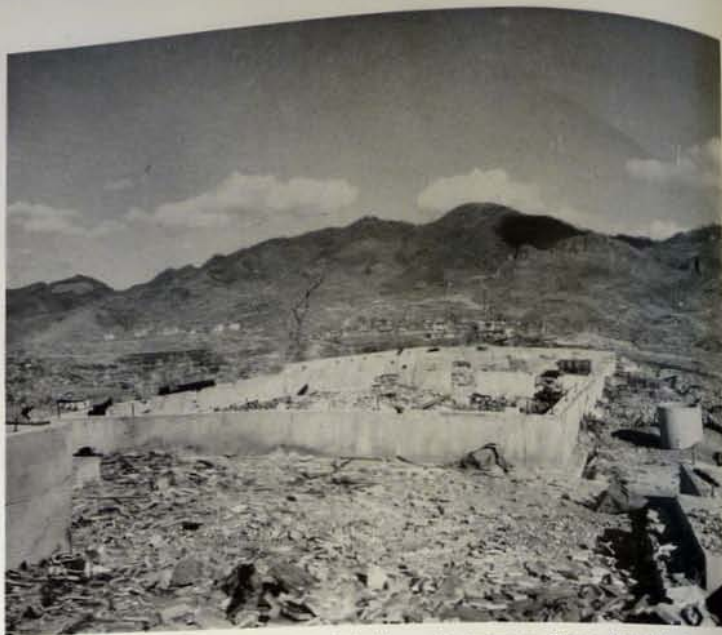
Remarks: Buildings demolished to foundations. Photo 208.

Photo 208.—2,800 feet from GZ. Group 25, looking south at remains of Keiho High School.

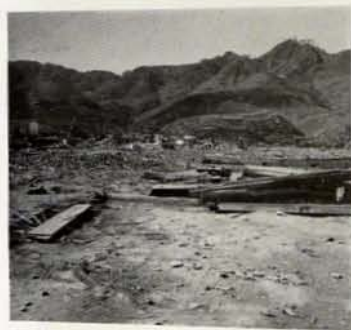
Remarks: Buildings demolished by blast. Photos 209 and 210.

Photo 209.—Group 25, looking west showing complete destruction by blast.

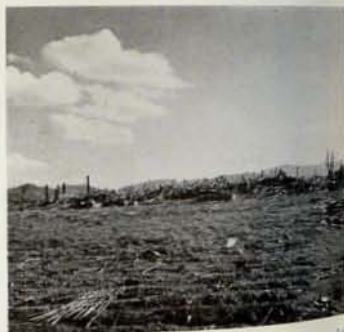
Photo 210.—Group 25, looking southwest at general view of site.

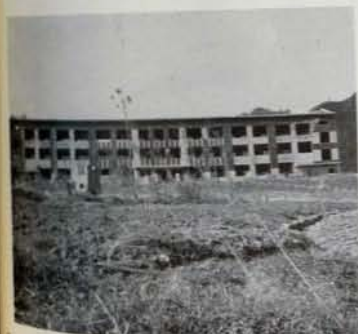
PHOTO 215.—Group 27, Building 1, looking southwest at northeast side.
